## II. Photographs 36-50: Dachau

TOPF double-muffle mobile cremation furnace, fueled with naphtha, converted to a stationary, coke-fired furnace at Concentration Camp Dachau. December 1990. © CARLO MATTOGNO for all photographs.

### III. Photographs 51-85: Mauthausen

TOPF coke-fired double-muffle cremation furnace at Concentration Camp Mauthausen. December 1990. © Carlo Mattogno for all photographs.

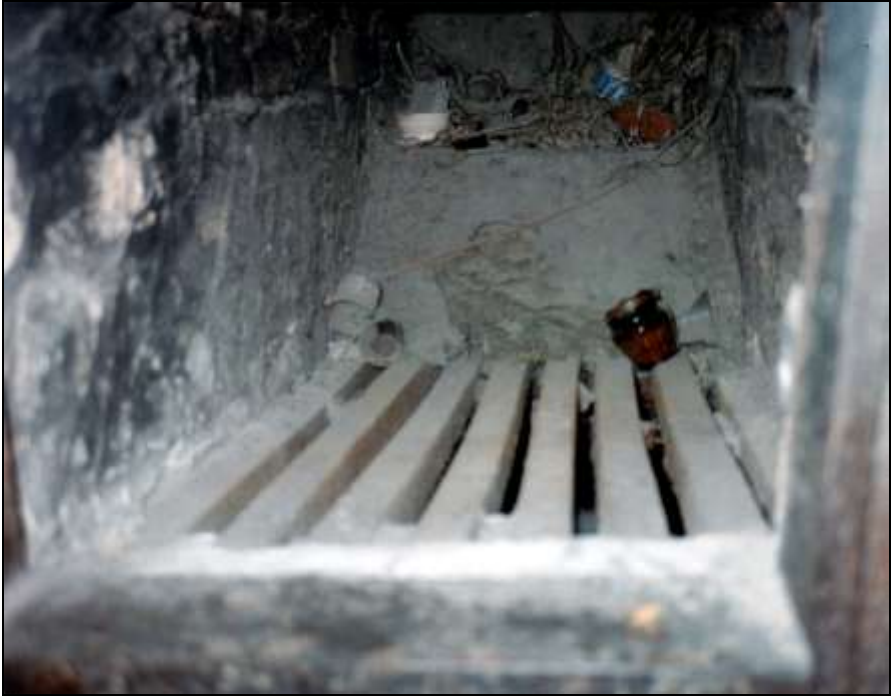
*Photograph 99: Furnace No. 2: original gasifier grate with seven longitudinal bars and two transverse bars.*

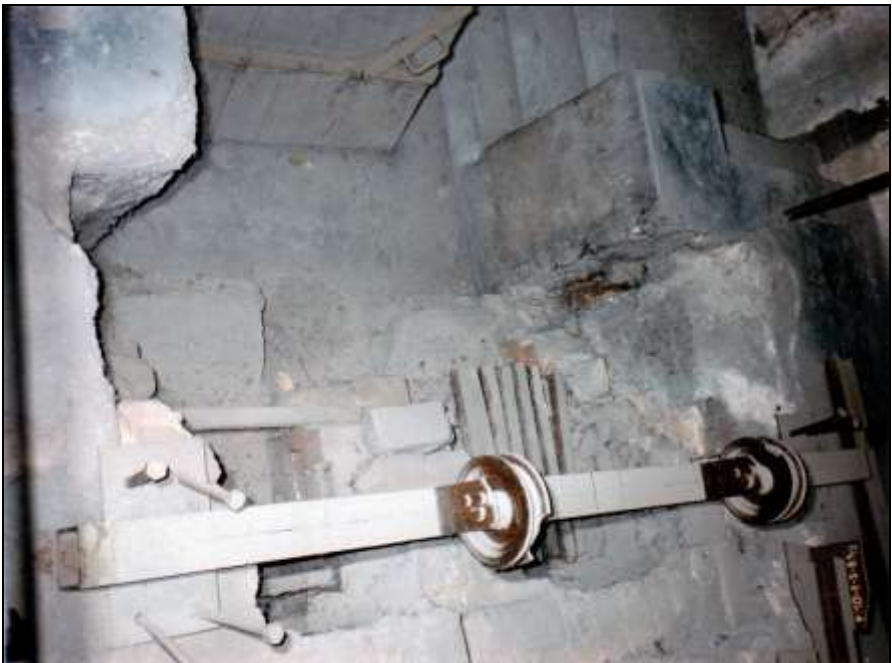
*Photograph 100: Ruins of the foundations of Furnace No. 3: service pit and the gasifier hearths seen from the top.*

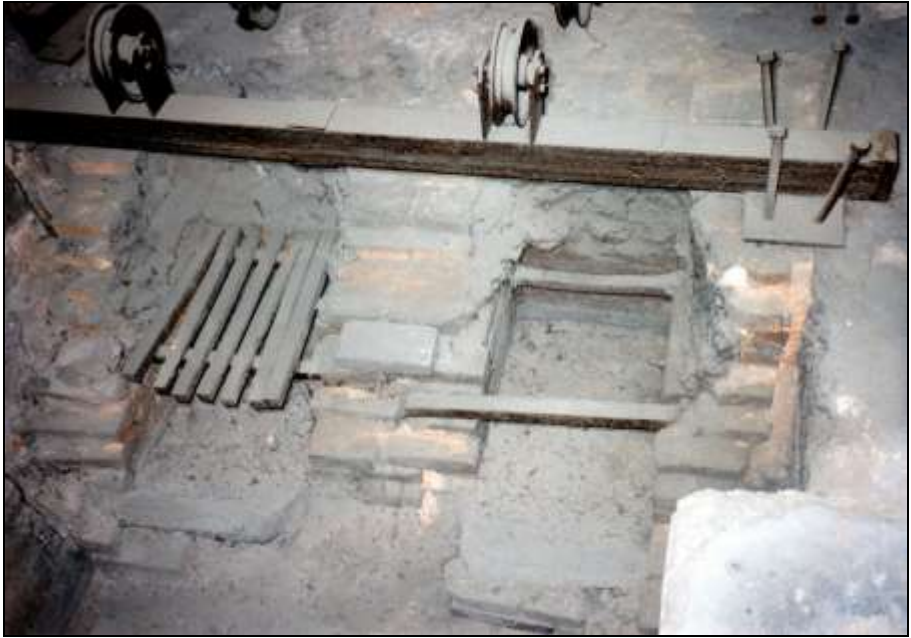
*Photograph 101: as above, seen from the rear: original grate of the left-hand gasifier and the two transverse support bars of the right-hand grate. The bar with the rollers, originally attached to the ceiling, was used to operate the furnace's two flue dampers.*

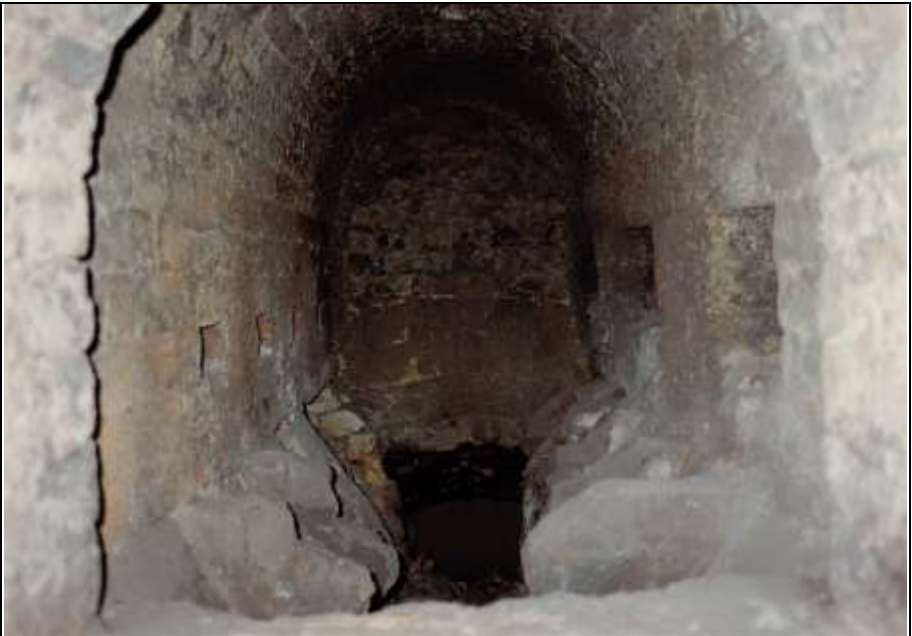
*Photograph 140: Coke-fired triple-muffle furnace, left-hand muffle. Left wall: square openings of the combustion-air feed. Bottom: wall sloping into the ash chamber). Center bottom: opening to the gasifier. Right-hand wall: rectangular inter-muffle openings. The muffle-grate bars have been ripped out.*

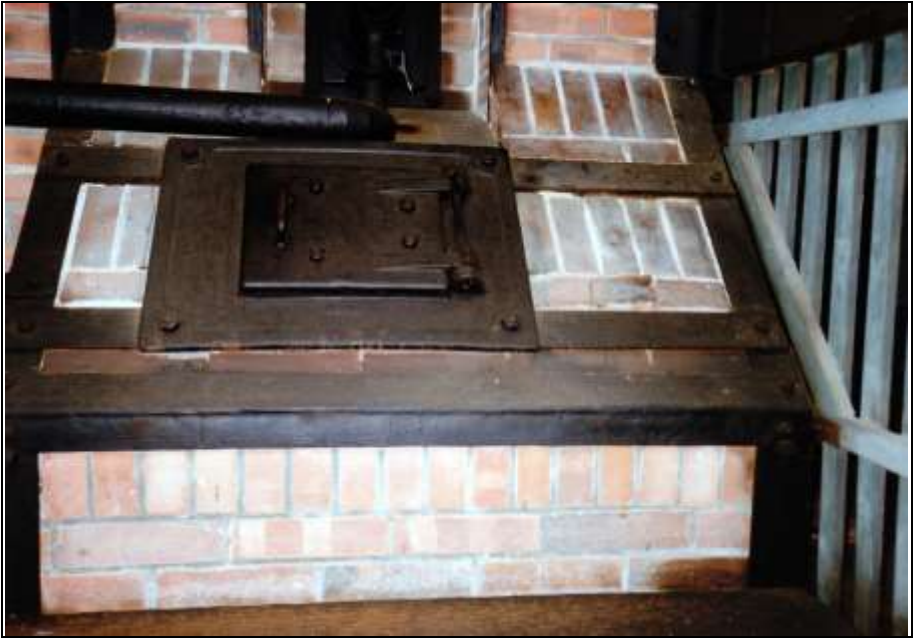
*Photograph 161: as above.*

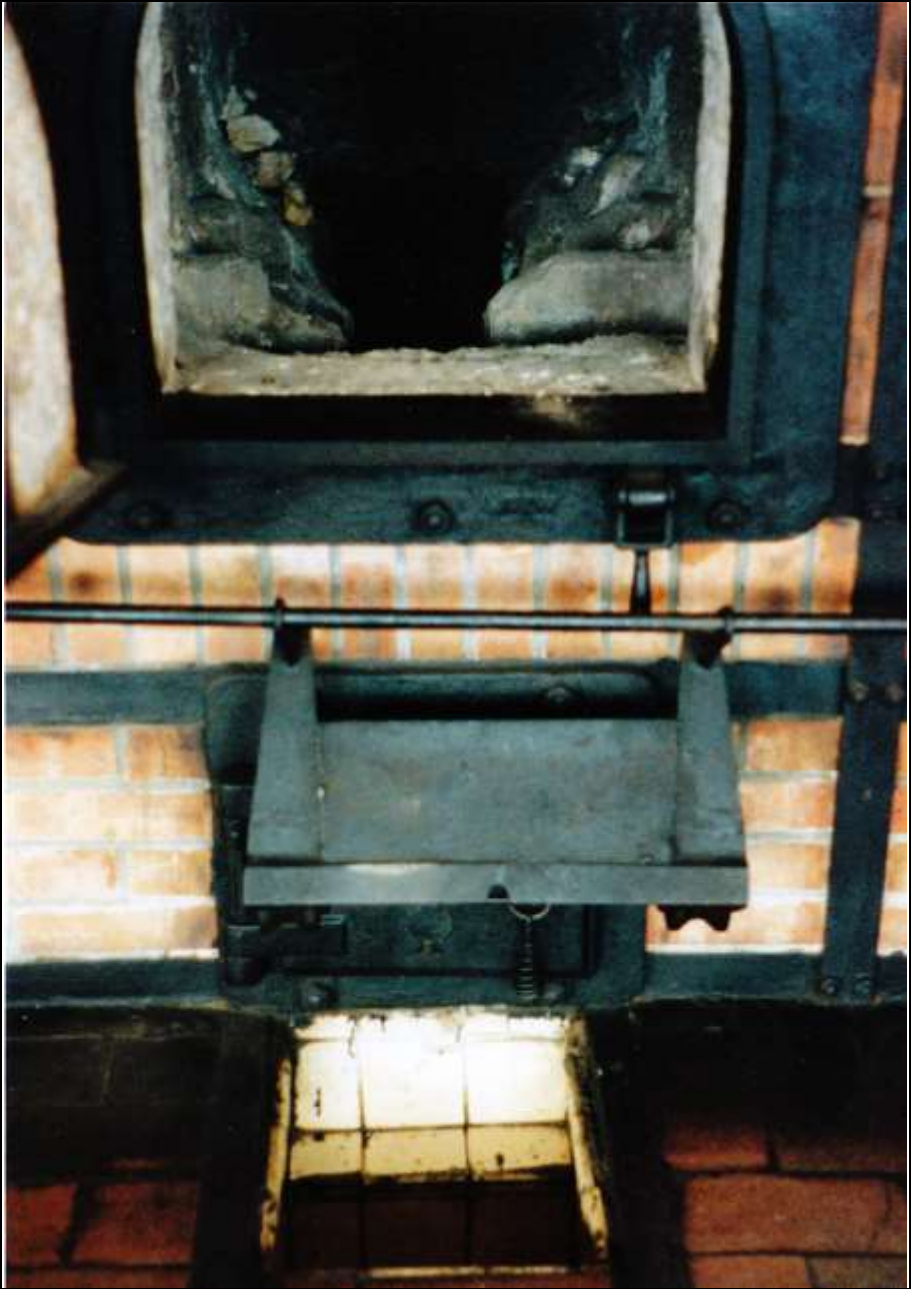
*Photograph 178: as above, front view, central muffle. The lowered movable roller device. The device is threaded through the mounting bar, can pivot vertically and move horizontally.*

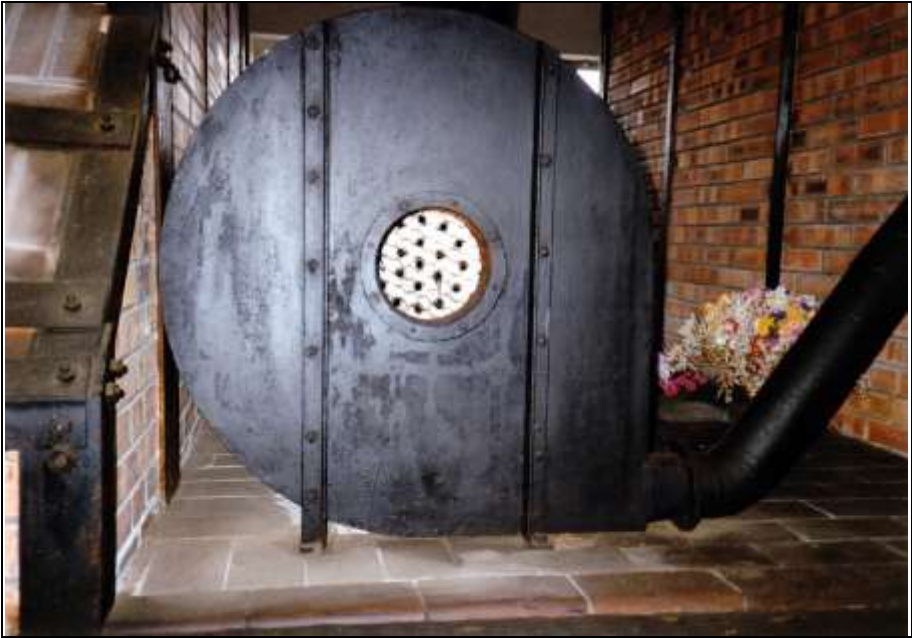
*Photograph 195: Combustion-air blower for the oil burner of the furnace fueled with either naphtha or coke. Rear view.*

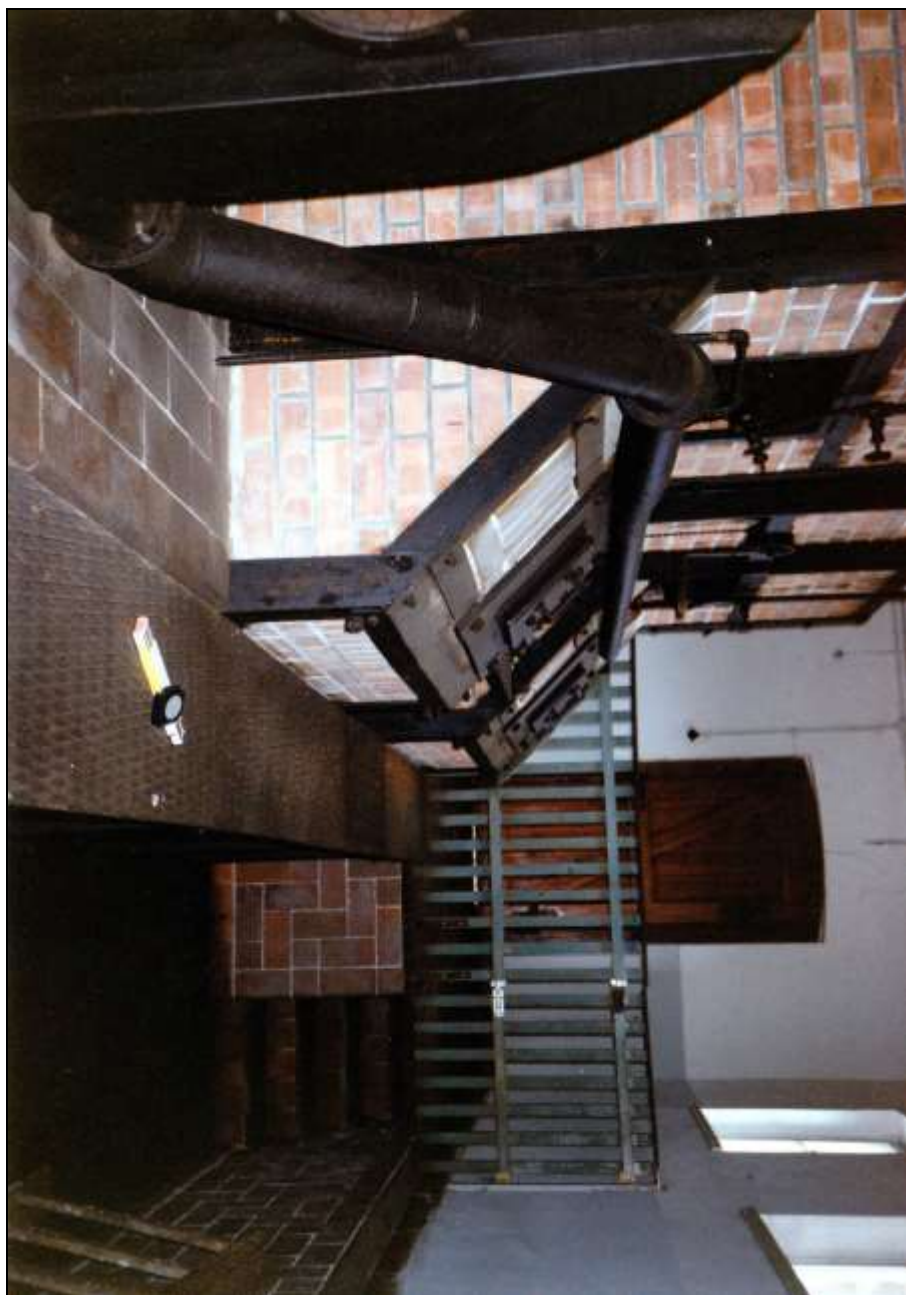
*Photograph 199: as above, tube detail.*

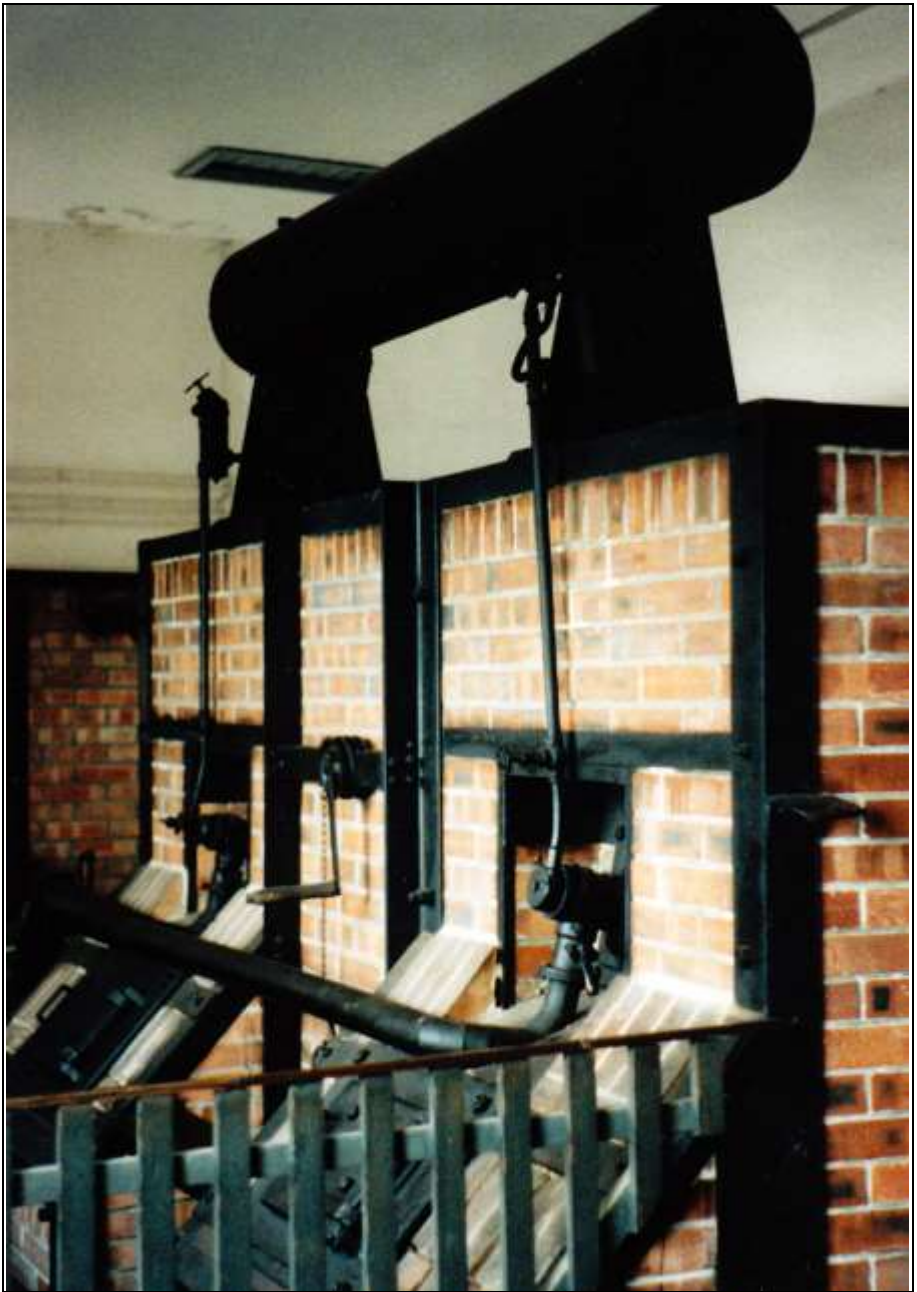
*Photograph 201: as above, right-side rear view; tube connection with naphtha burner.*

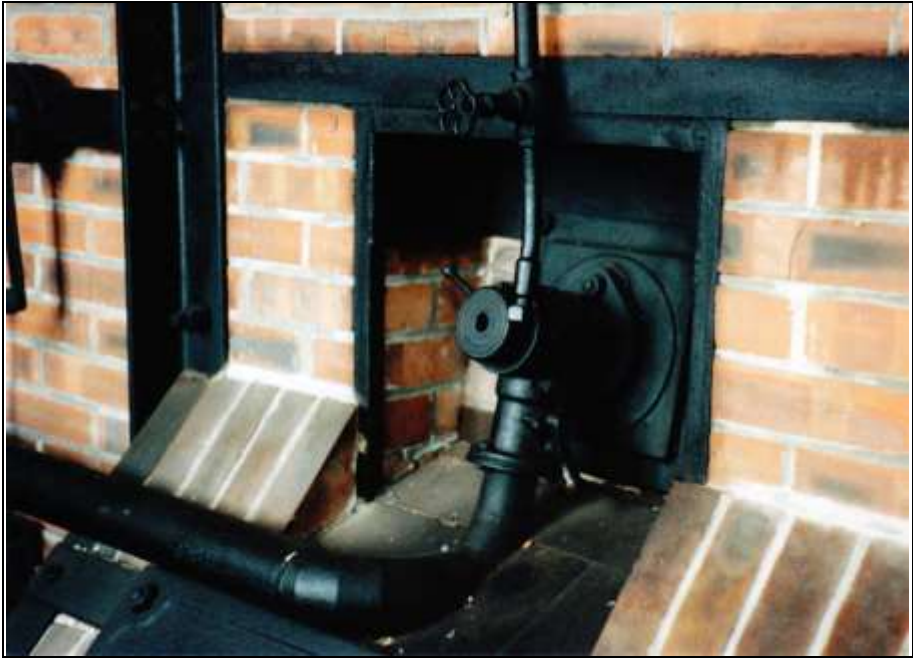
*Photograph 204: as above, rear view, naphtha burner of the left-hand muffle; connected to the naphtha burner are from above, the tube feeding oil from the naphtha tank, and from below, the tube from the combustion-air blower.*

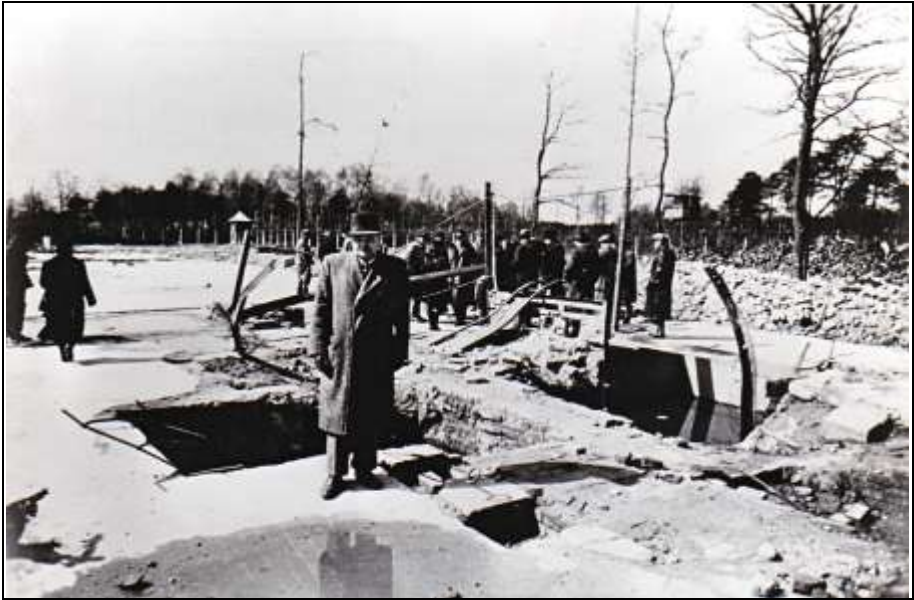
*Photograph 222: Ruins of Crematorium V. Wrought-iron frame of the TOPF eight-muffle furnace and service pit. Polish photo of May 1945. APMO, Negative No. 21334/141.*

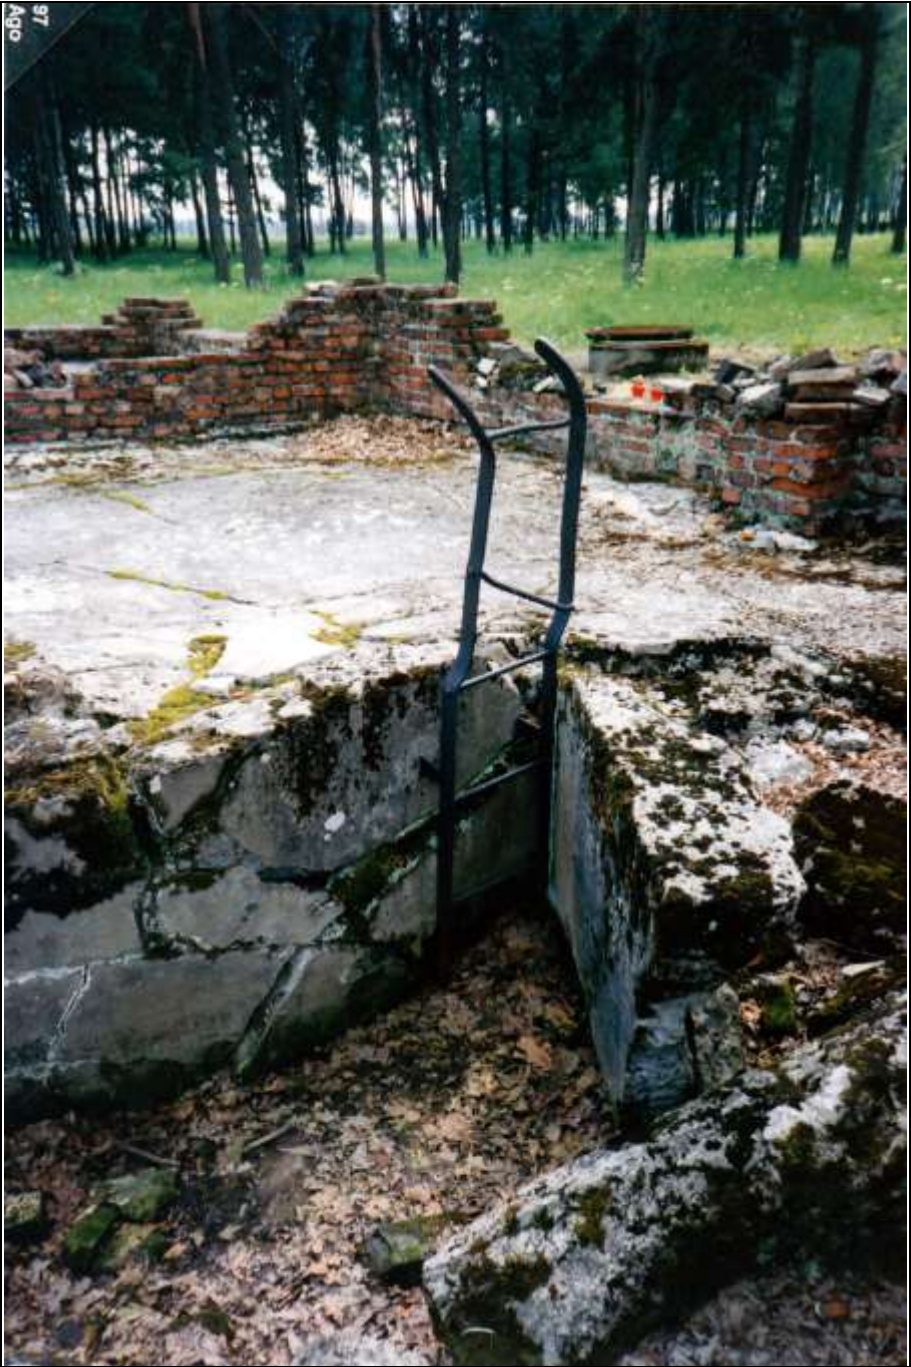
*Photograph 232: as above. South service pit and access ladder.*

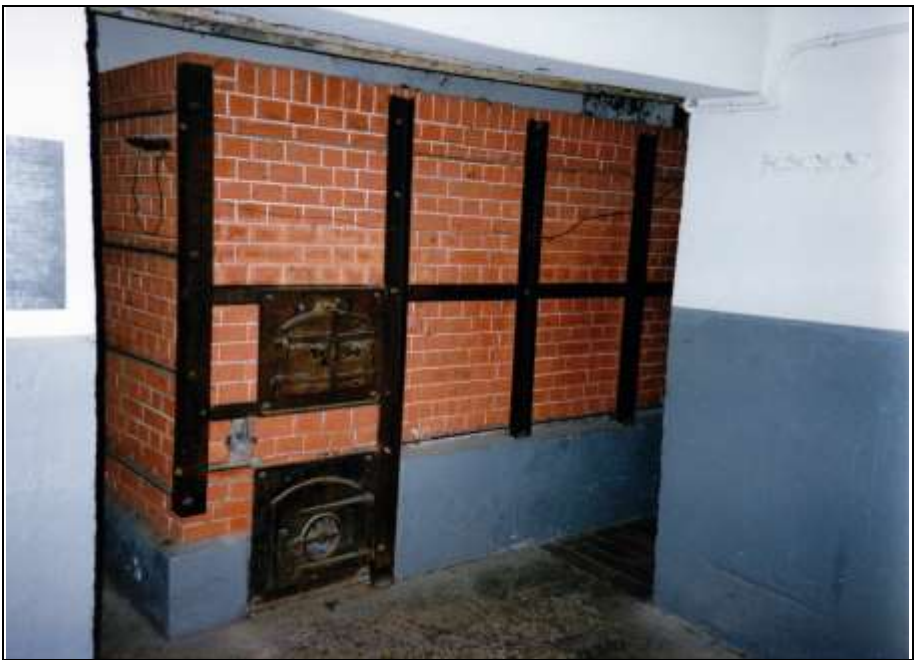
*Photograph 245: left-hand side view; the gasifier's coke-loading door (top) and ash door (bottom).*

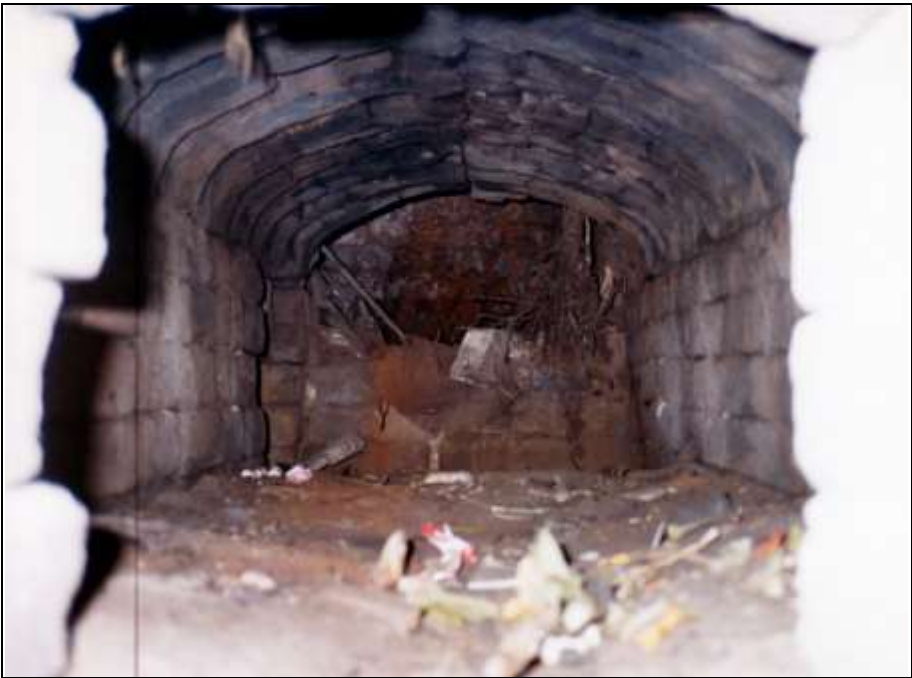
*Photograph 273: The ash chamber of the left-hand muffle. Top: underside of the muffle's grate bars. On the left wall in the rear: opening connecting it with the auxiliary hearth. All the way at the back: the gasifier's pit.*

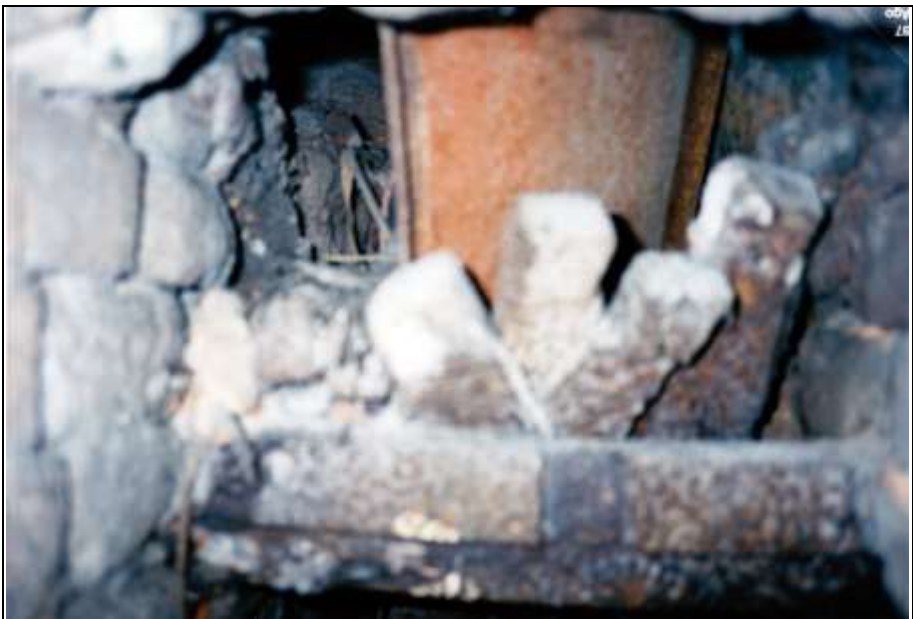
*Photograph 277: Inside the right-hand furnace's main gasifier viewed through the ash-chamber door. The hearth's grate has been damaged, with only four remaining bars merely leaning against the outer support bar.*

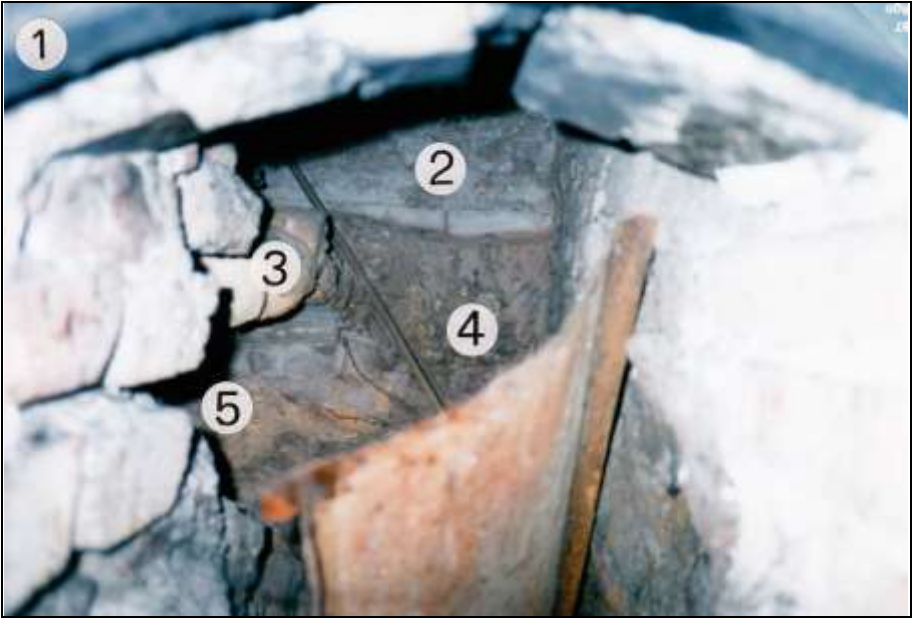
*Photograph 278: as above, seen through the coke-loading door. 1: door frame; 2: muffle; 3: muffle grate; 4: gasifier pit; 5: ash chamber.*

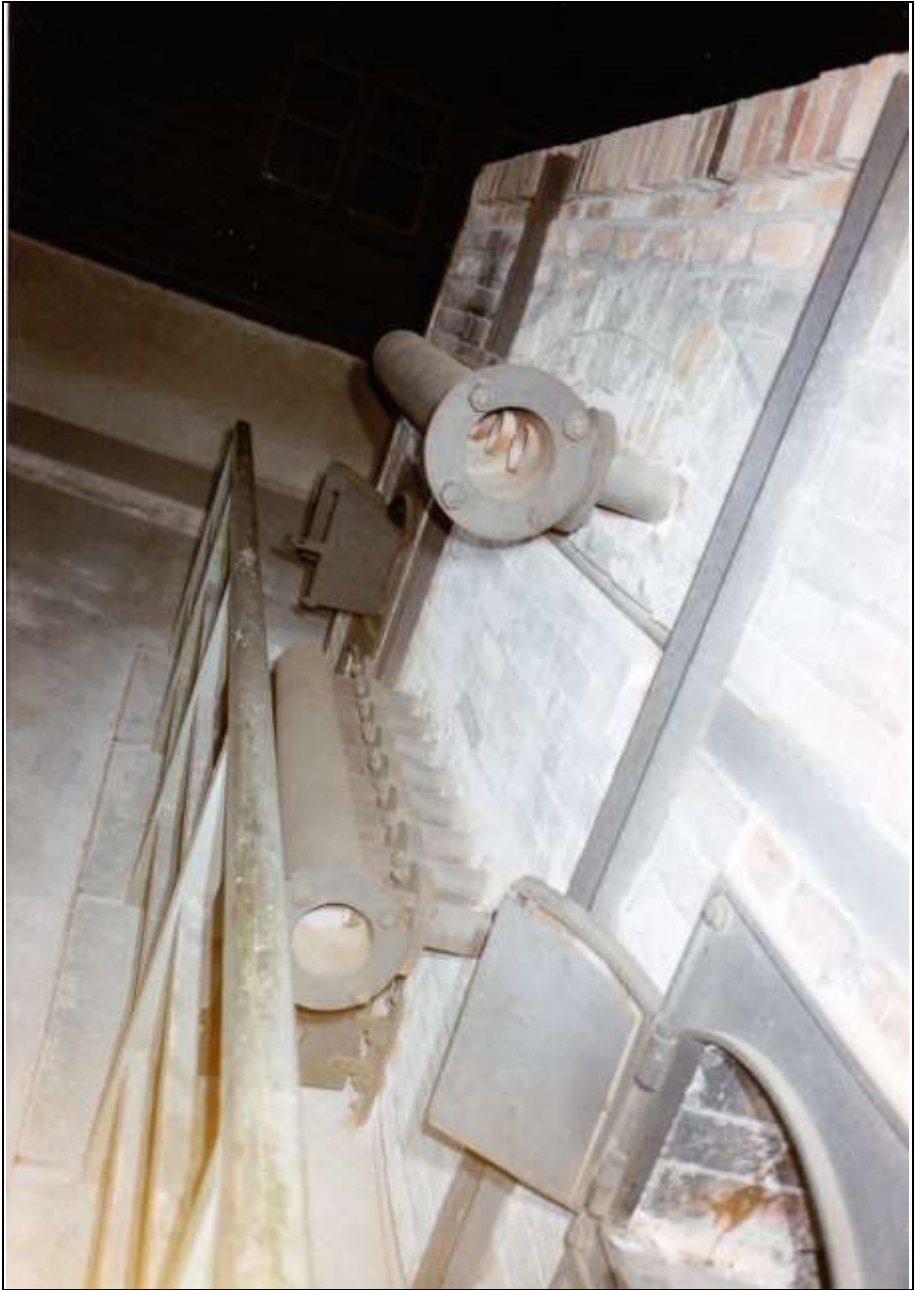
*Photograph 308: as above. Hot-water pipes of the recuperator.*

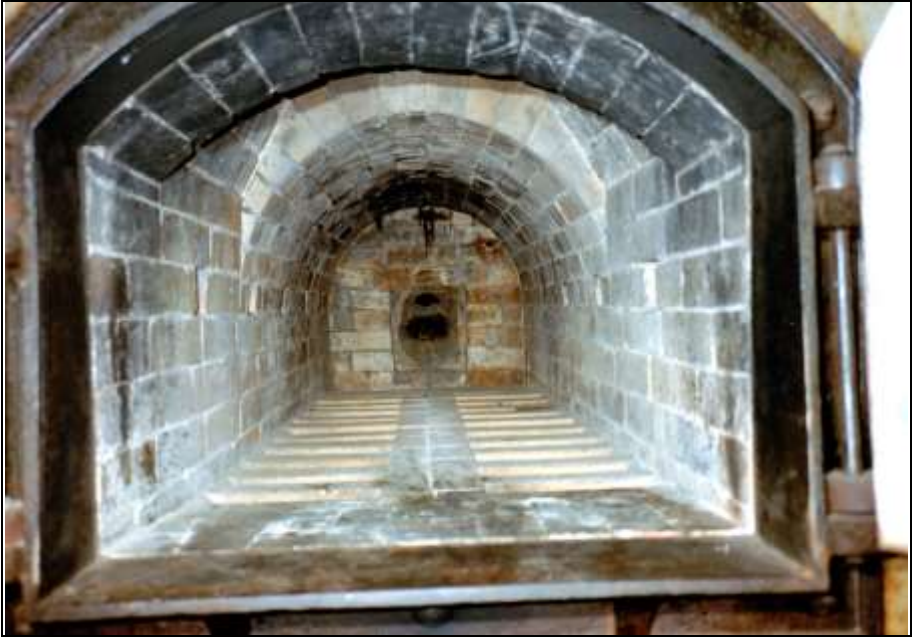
*Photograph 320: Inside of the muffle. Bottom: the refractory grate; on the back wall: the main burner's nozzle; on the side walls: openings of the combustion-air-supply channels.*

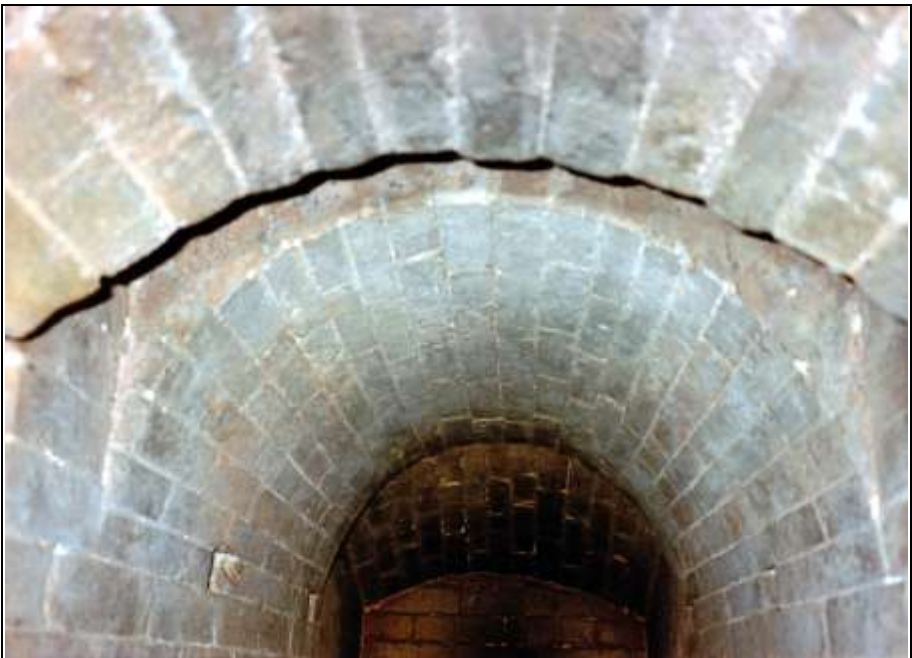
*Photograph 321: as above; the vaulted muffle ceiling with the smoke-duct opening in the foreground.*

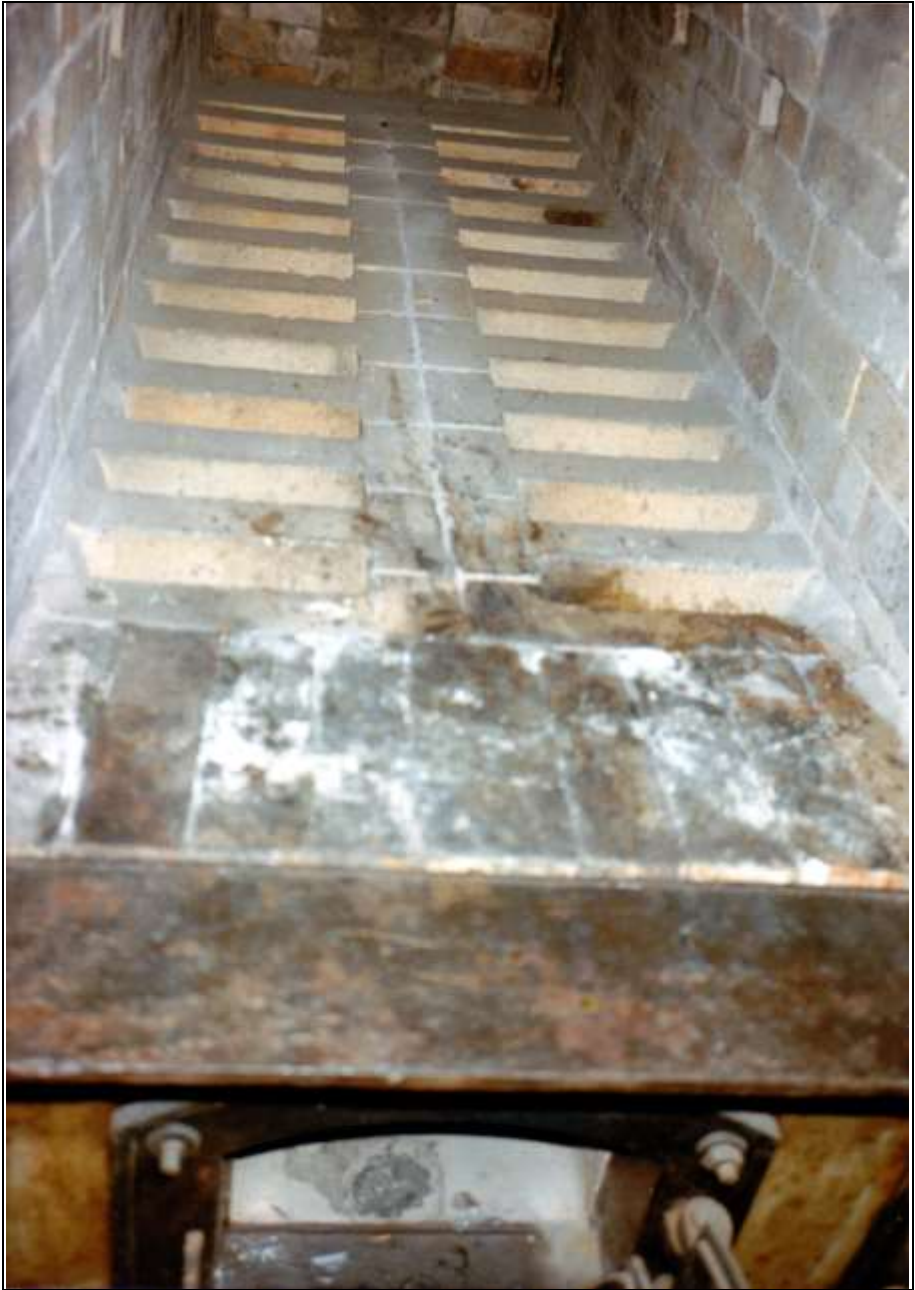
*Photograph 322: as above; the refractory grate; bottom: ash-chamber door.*

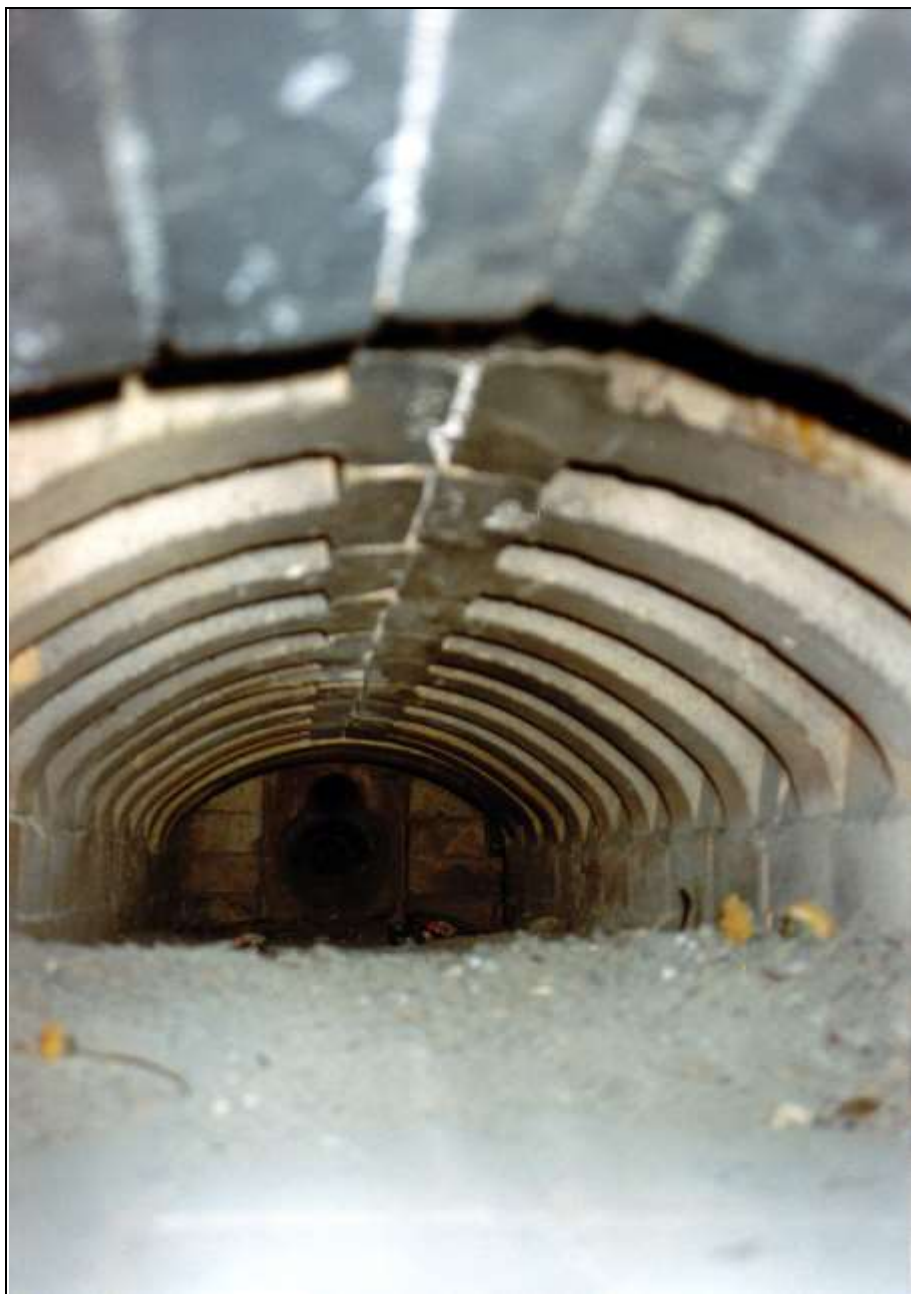
*Photograph 323: Ash chamber; top: the underside of the muffle's refractory grate; background: the auxiliary burner's nozzle.*

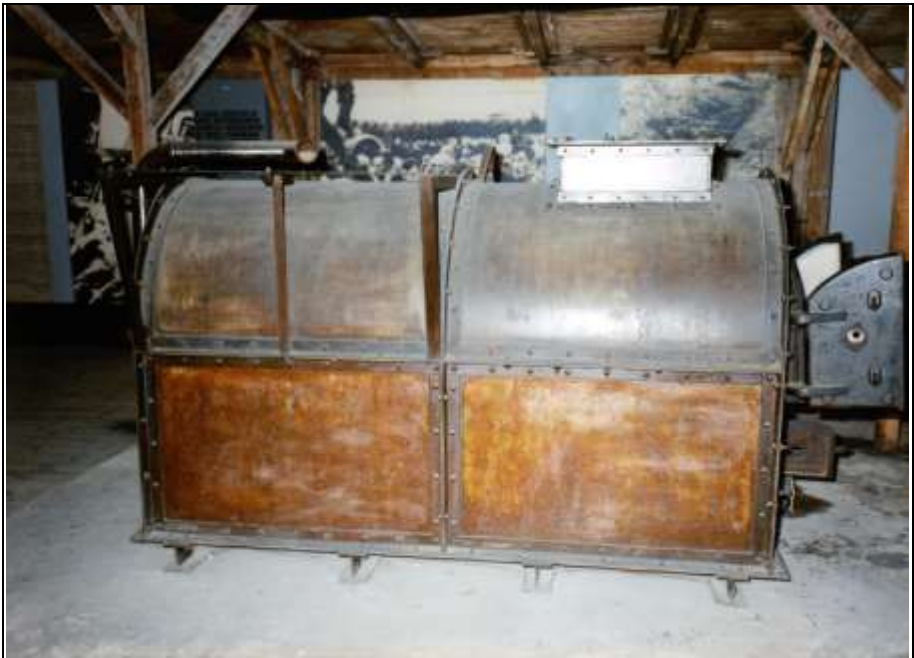
*Photograph 325: as above. In the upper part of the furnace can be seen the combustion-air pipe for the burners (left), the support bars for the fan and its motor (center), and the base of the chimney (right).*

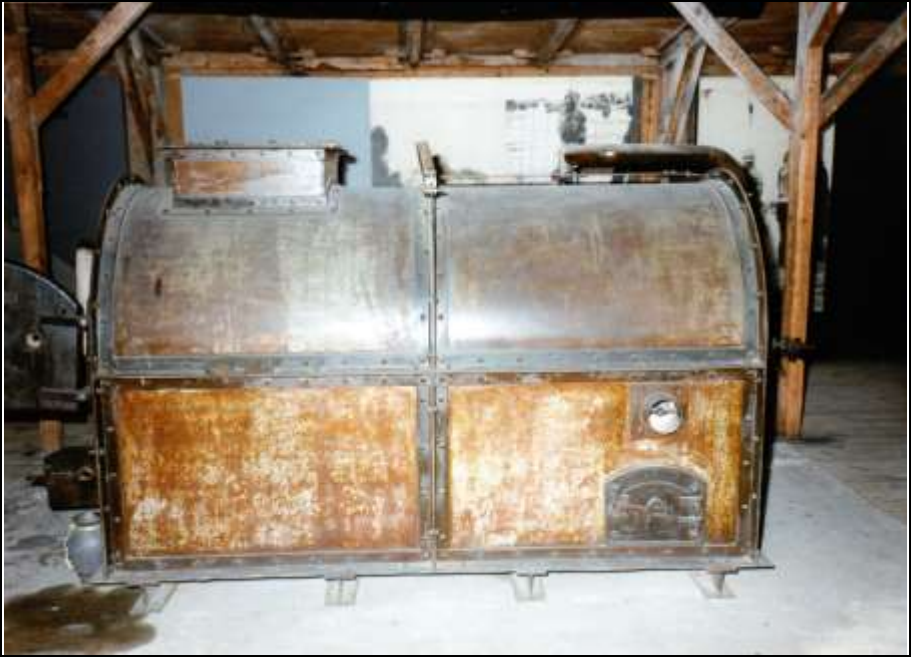
*Photograph 326: right-hand side; bottom right: side inspection door beneath a combustion-air inlet.*

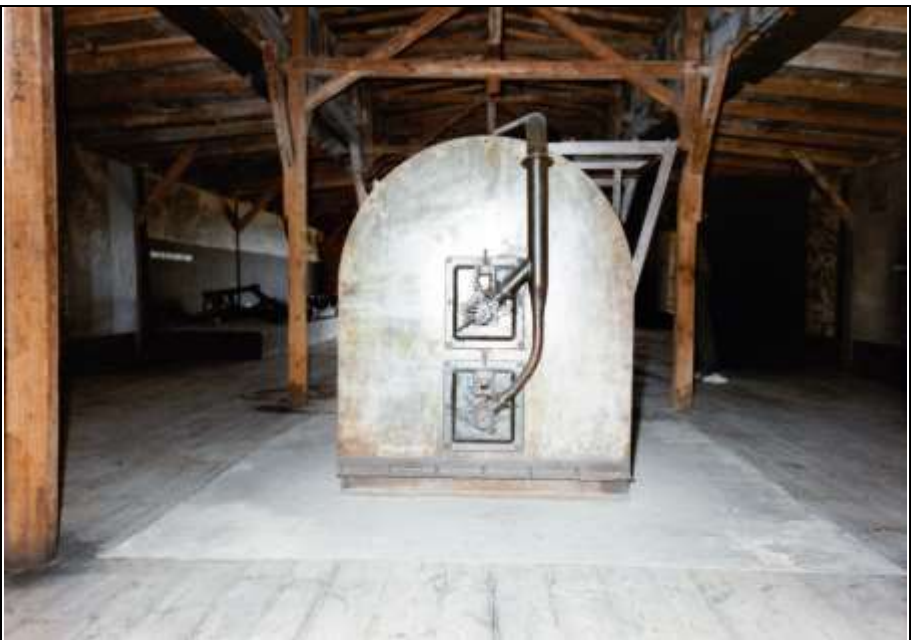
*Photograph 327: rear view; combustion-air pipe with main (center) and auxiliary burners (bottom).*

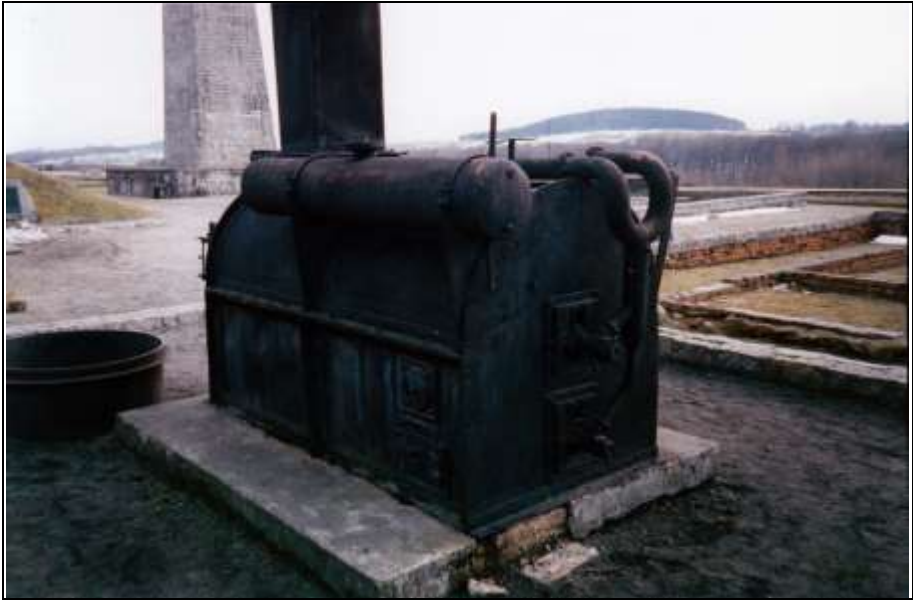
*Photograph 333a: rear view. Top left: naphtha tank; below it: combustion-air inlet and access door; top right: combustion-air pipes; rear end: main (top) and auxiliary burner (bottom).*

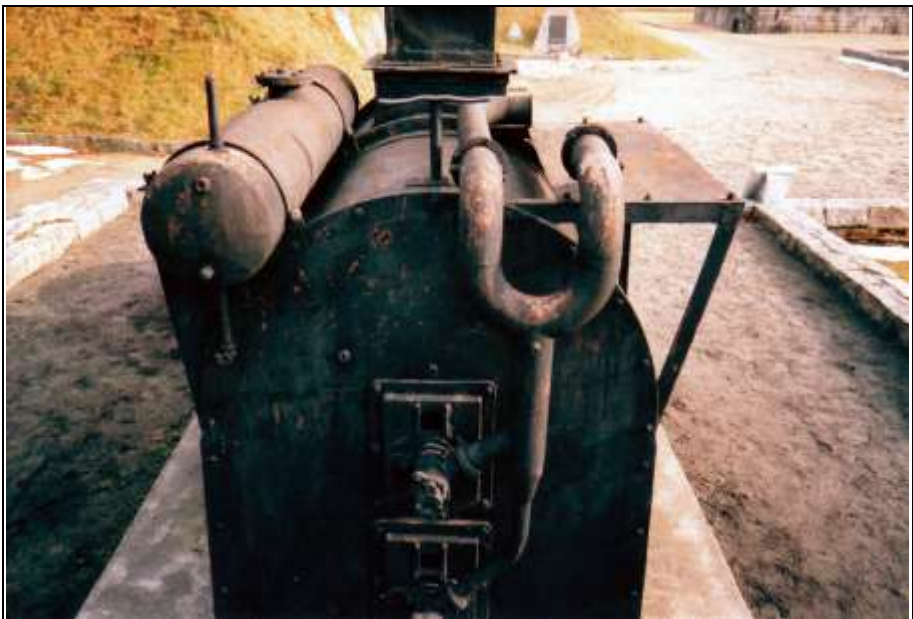
*Photograph 333b: as above. The air pipes were originally connected to a blower installed on the shelf to the right.*

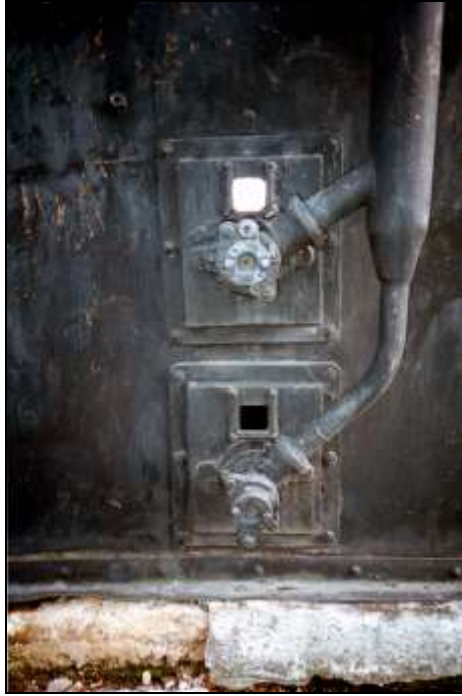
*Photograph 333c: rear view, main (top) and auxiliary burner (bottom)*

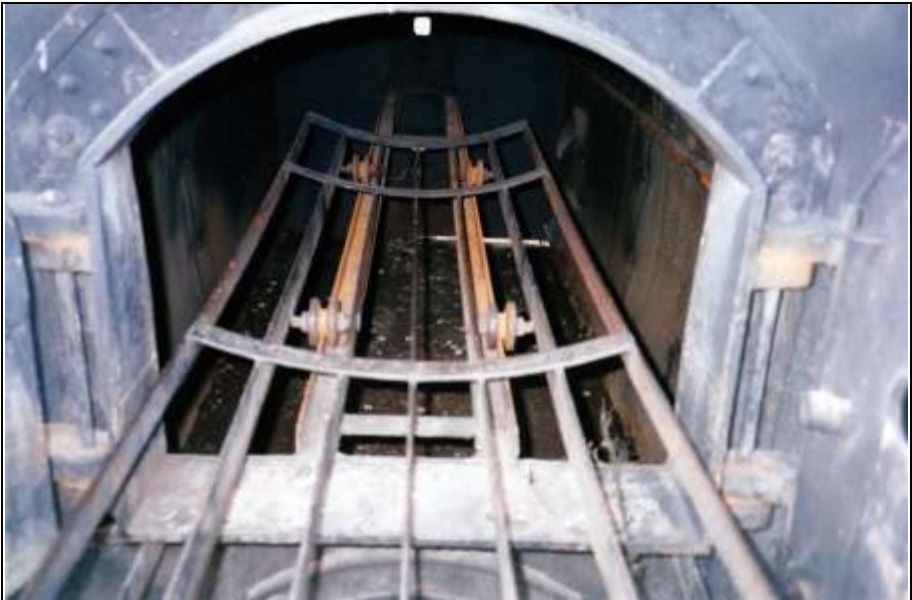
*Photograph 334: Interior. The introduction stretcher moved with four metal rollers on two angle irons. The opening in the back wall housed the main burner. The refractory lining has been completely removed.*

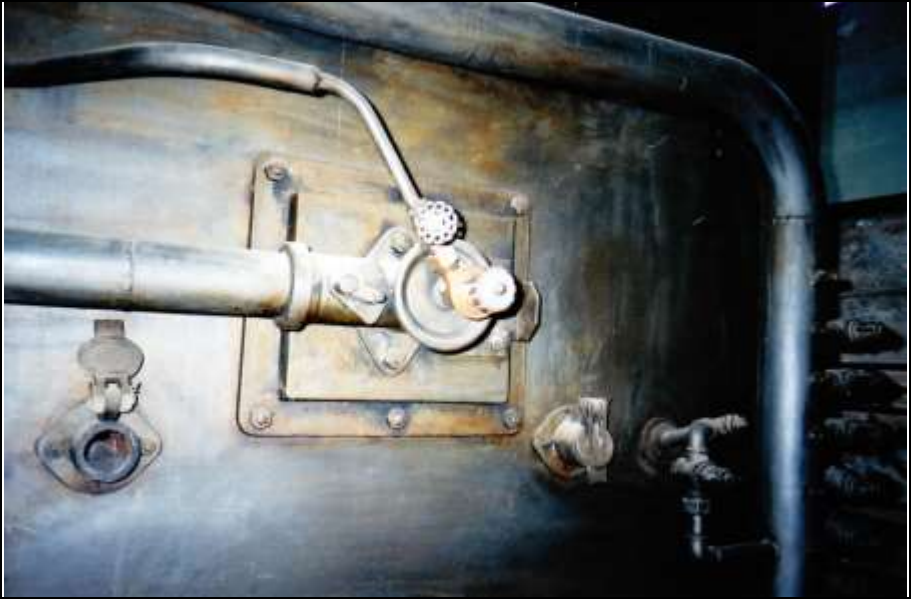
*Photograph 350: Right-hand furnace of the front pair, rear view, naphtha burner.*
