## II. Photographs 36-50: Dachau

TOPF double-muffle mobile cremation furnace, fueled with naphtha, converted to a stationary, coke-fired furnace at Concentration Camp Dachau. December 1990. © CARLO MATTOGNO for all photographs.

### III. Photographs 51-85: Mauthausen

TOPF coke-fired double-muffle cremation furnace at Concentration Camp Mauthausen. December 1990. © Carlo Mattogno for all photographs.

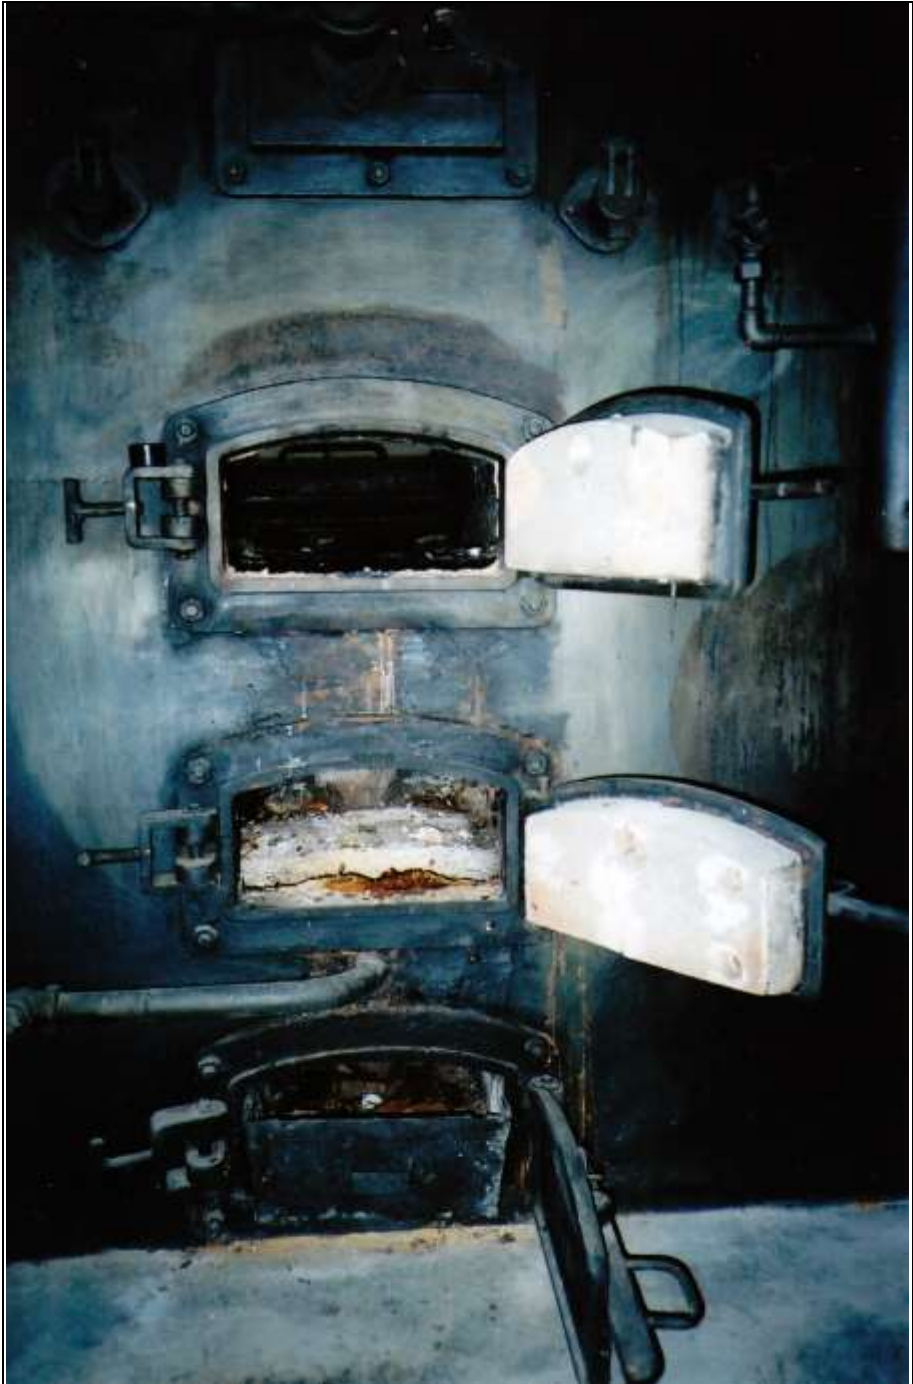
*Photograph 351: Left-hand furnace of the front pair, rear view; the three service doors: for the muffle (top), the post-combustion chamber (center) and the ash chamber with the ash receptacle (bottom).*

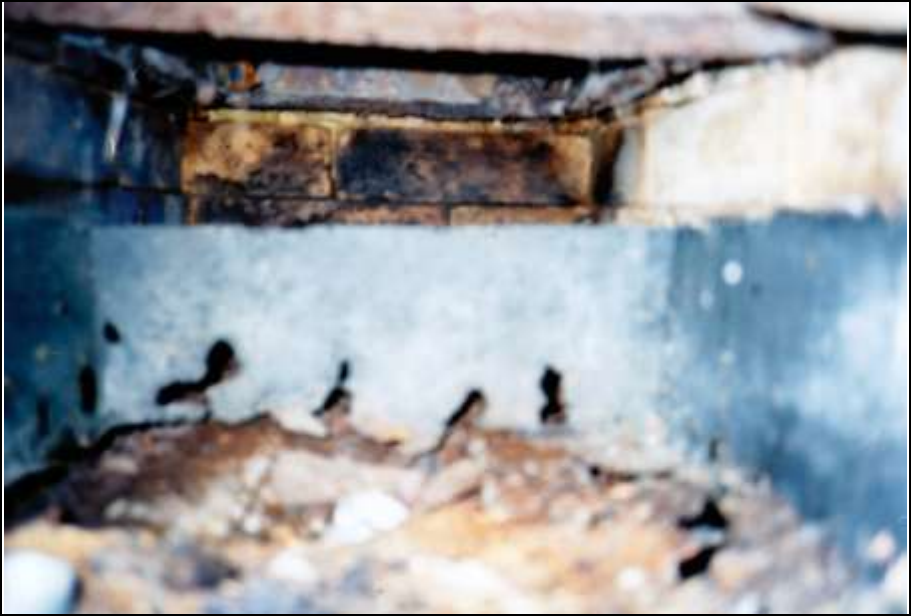
*Photograph 355: as above; inside of the ash chamber seen through its rear service door, with the corroded iron ash container.*

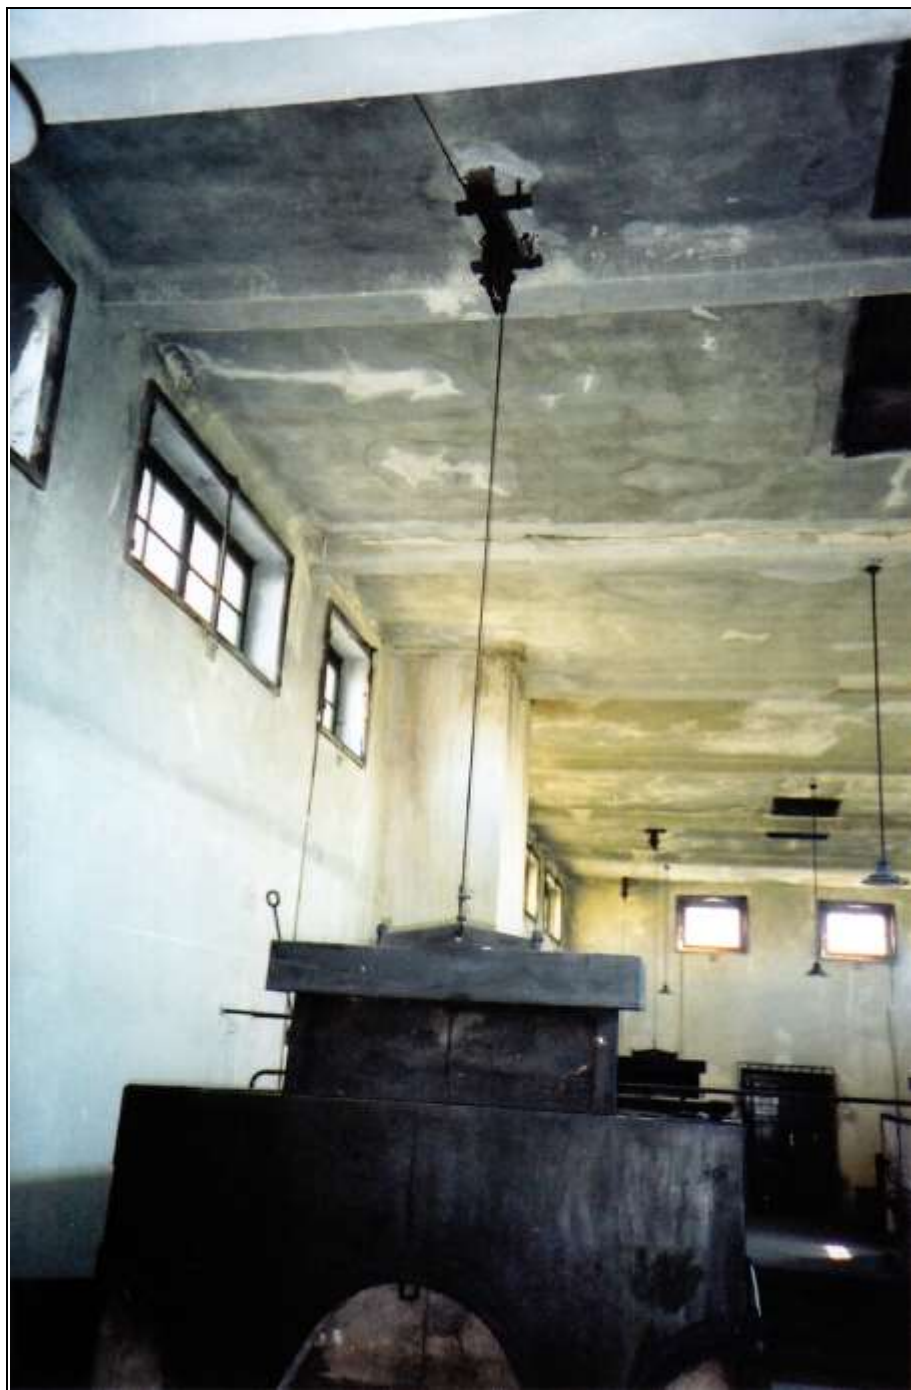
*Photograph 360: left-hand furnace of front pair, front view; the damper's steel cable and pulley attached to the ceiling.*
